**Chiloquin Highway  
Revegetation Project  
Final Monitoring Report**

**March 29, 2007**

**David Steinfeld**

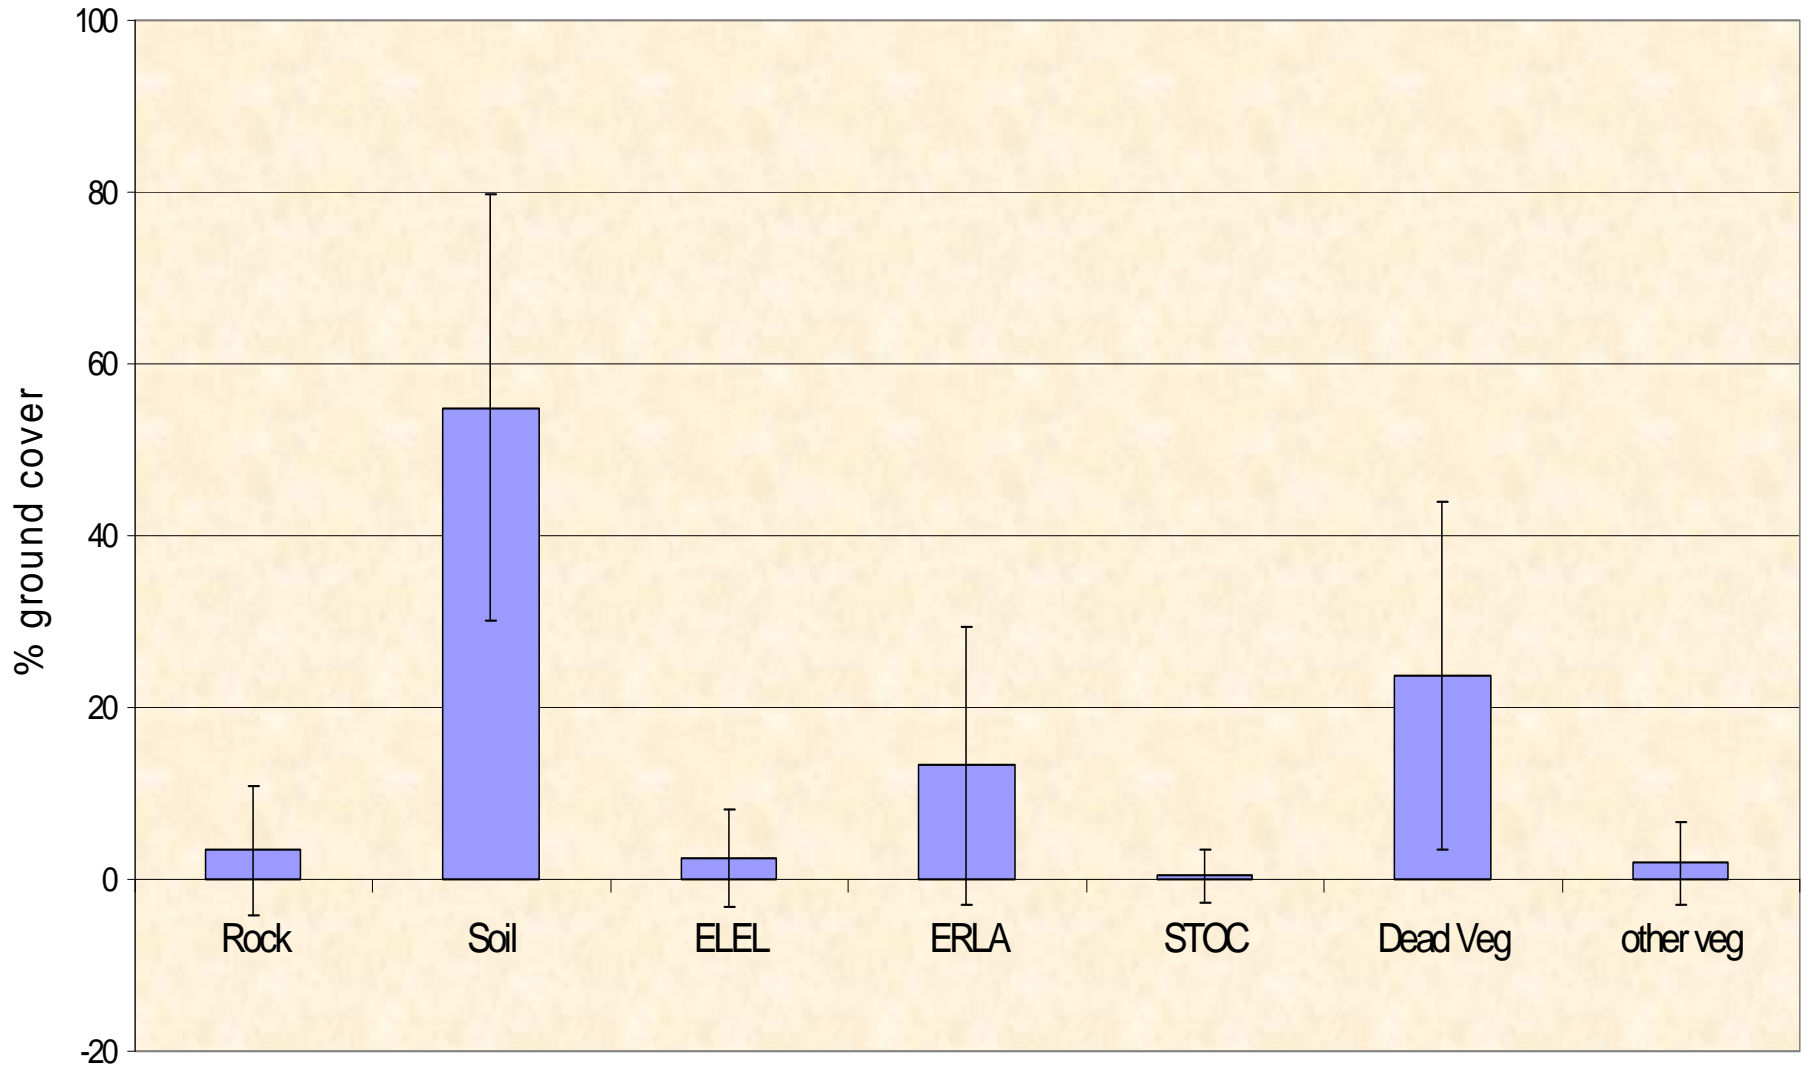
A quick look at this monitoring data should raise some eyebrows - what the eye sees in the previous photographs might not seem to reflect what the data in the bar chart is showing. There doesn't appear to be over 50% bare soil when looking at the photographs from a landscape view, but the flowers and vegetation hide, even distract from, what is really going on at the surface of the soil.

So is 50% bare soil a big deal? Since we did not establish a criteria for “success” during the planning stages, this is somewhat of a debatable question. If the criteria for success is that the roadside is visually appealing when in the full flowering stage, I think we would all agree that this project was successful. If we established a success criteria that the majority of the species now on the site be native, this project would also be considered successful (85% of the ground cover of live vegetation is from the native species that we sowed). If we were to judge this monitoring data against EPA Standards for cover however, we would have a range of answers from “successful” to “unsuccessful” because of the ambiguity of the standards (a discussion of the applicability of EPA Standards is presented in supporting document titled “The Need for Developing Clear Standards Tailored to Revegetation Projects”).

The importance of establishing “success” standards during planning cannot be overemphasized. An objectives-based monitoring strategy is discussed in length in the Roadside Revegetation Manual (out later this year).

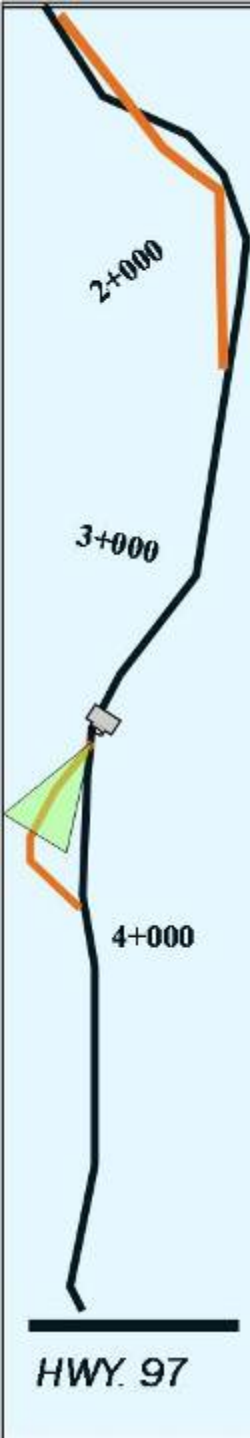
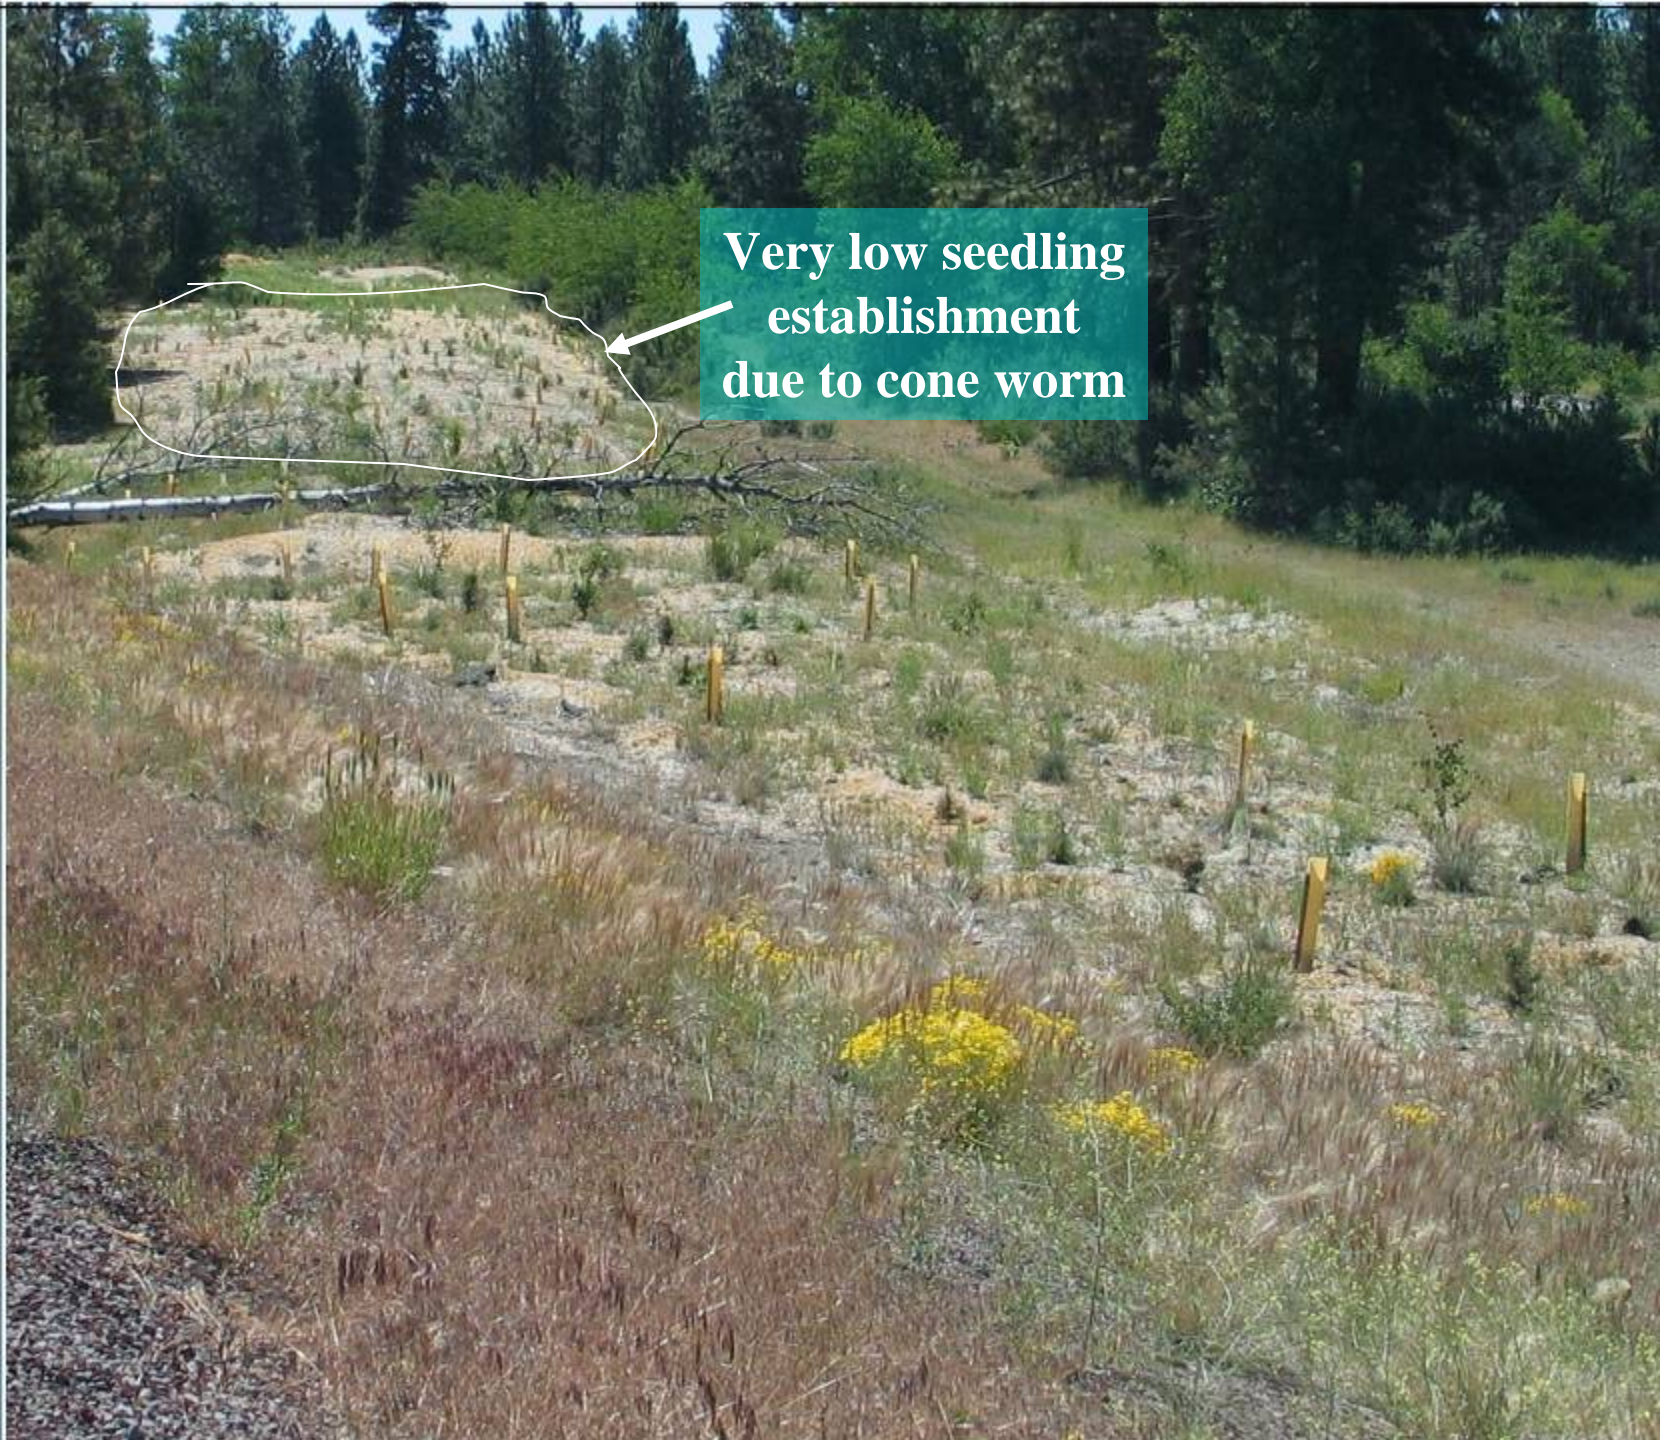
First year monitoring showed that the ponderosa pine was infested by the cone worm insect (*Diaryctria* sp). This insect lays eggs on the buds of the terminal leader of the tree and hatching larvae mine through the new leader growth, destroying the entire years growth. This happened two years in a row. In the western portion of the road (a), this damage, weakened the seedlings to the point that most ponderosa pine in this area did not survive by the end of the third year.

The area that was severely affected by the cone moth was replanted in March 2006 with lodgepole pine seedlings because this species is not affected by the cone worm insect. Because we had no time to grow larger container seedlings, the size of the seedlings that were planted last spring were of bareroot stocktype and small. They performed poorly and an evaluation of them this spring indicates that survival rates will be very low this year. While this area is not stocked with trees at this time, it should fill in with seedling over the coming decade from the seed of the adjacent pine trees.

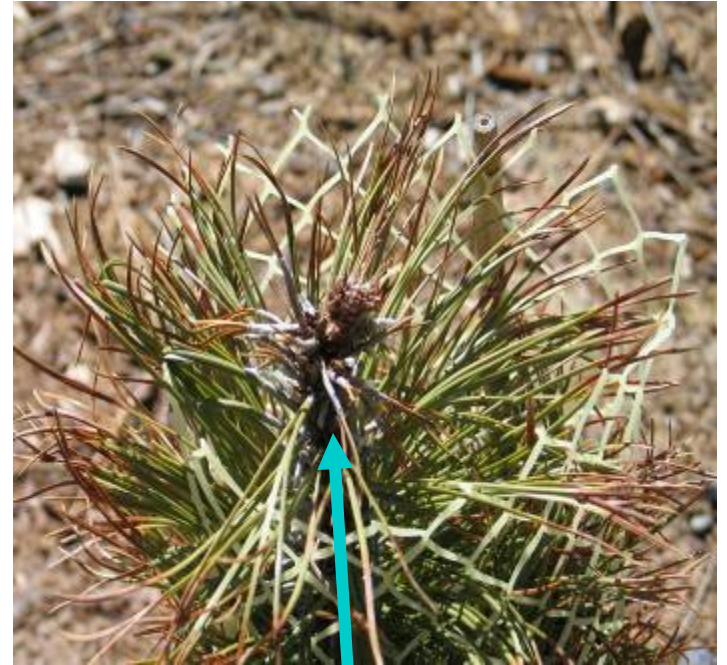
**Bud and leader  
destroyed by  
cone worm**

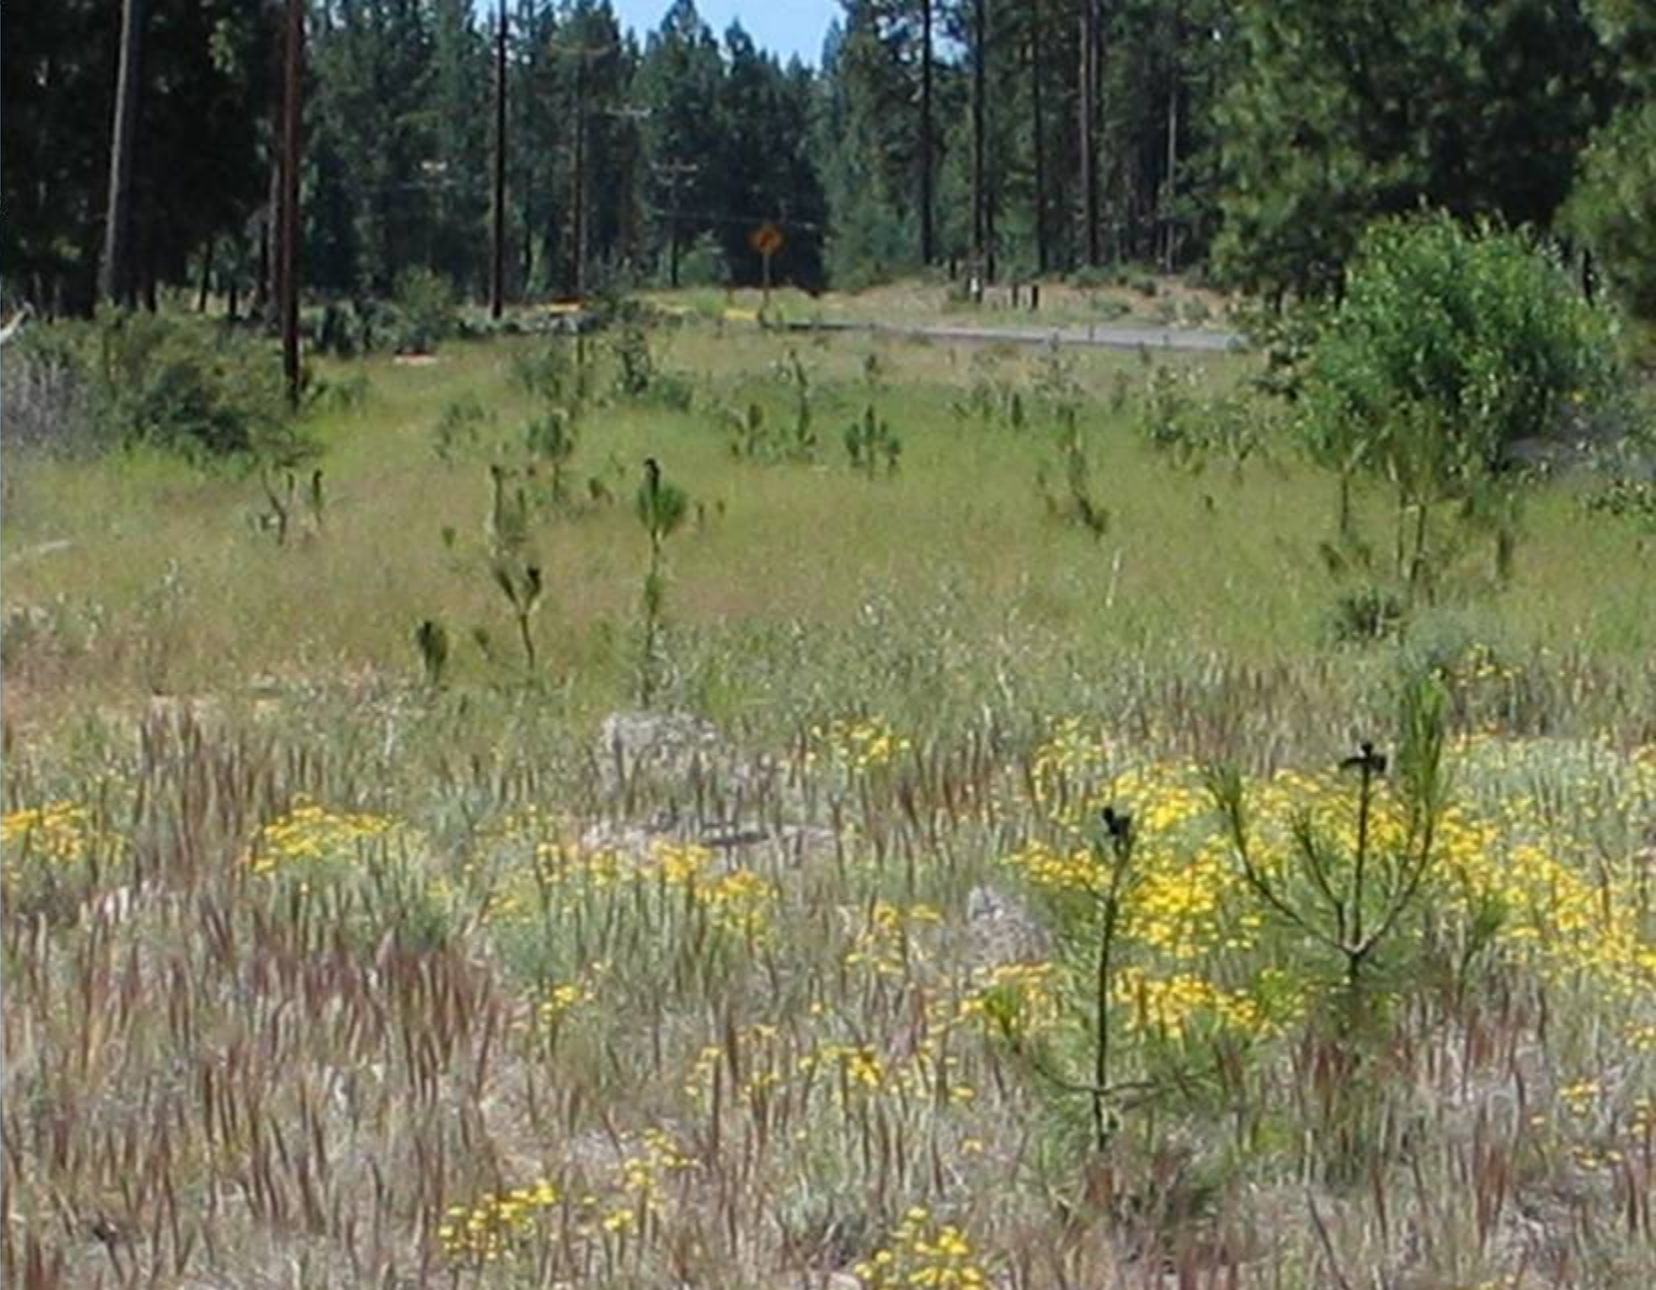
**The black cloth over the top of the ponderosa pine are bud caps we placed to protect the seedling from the cone moth**

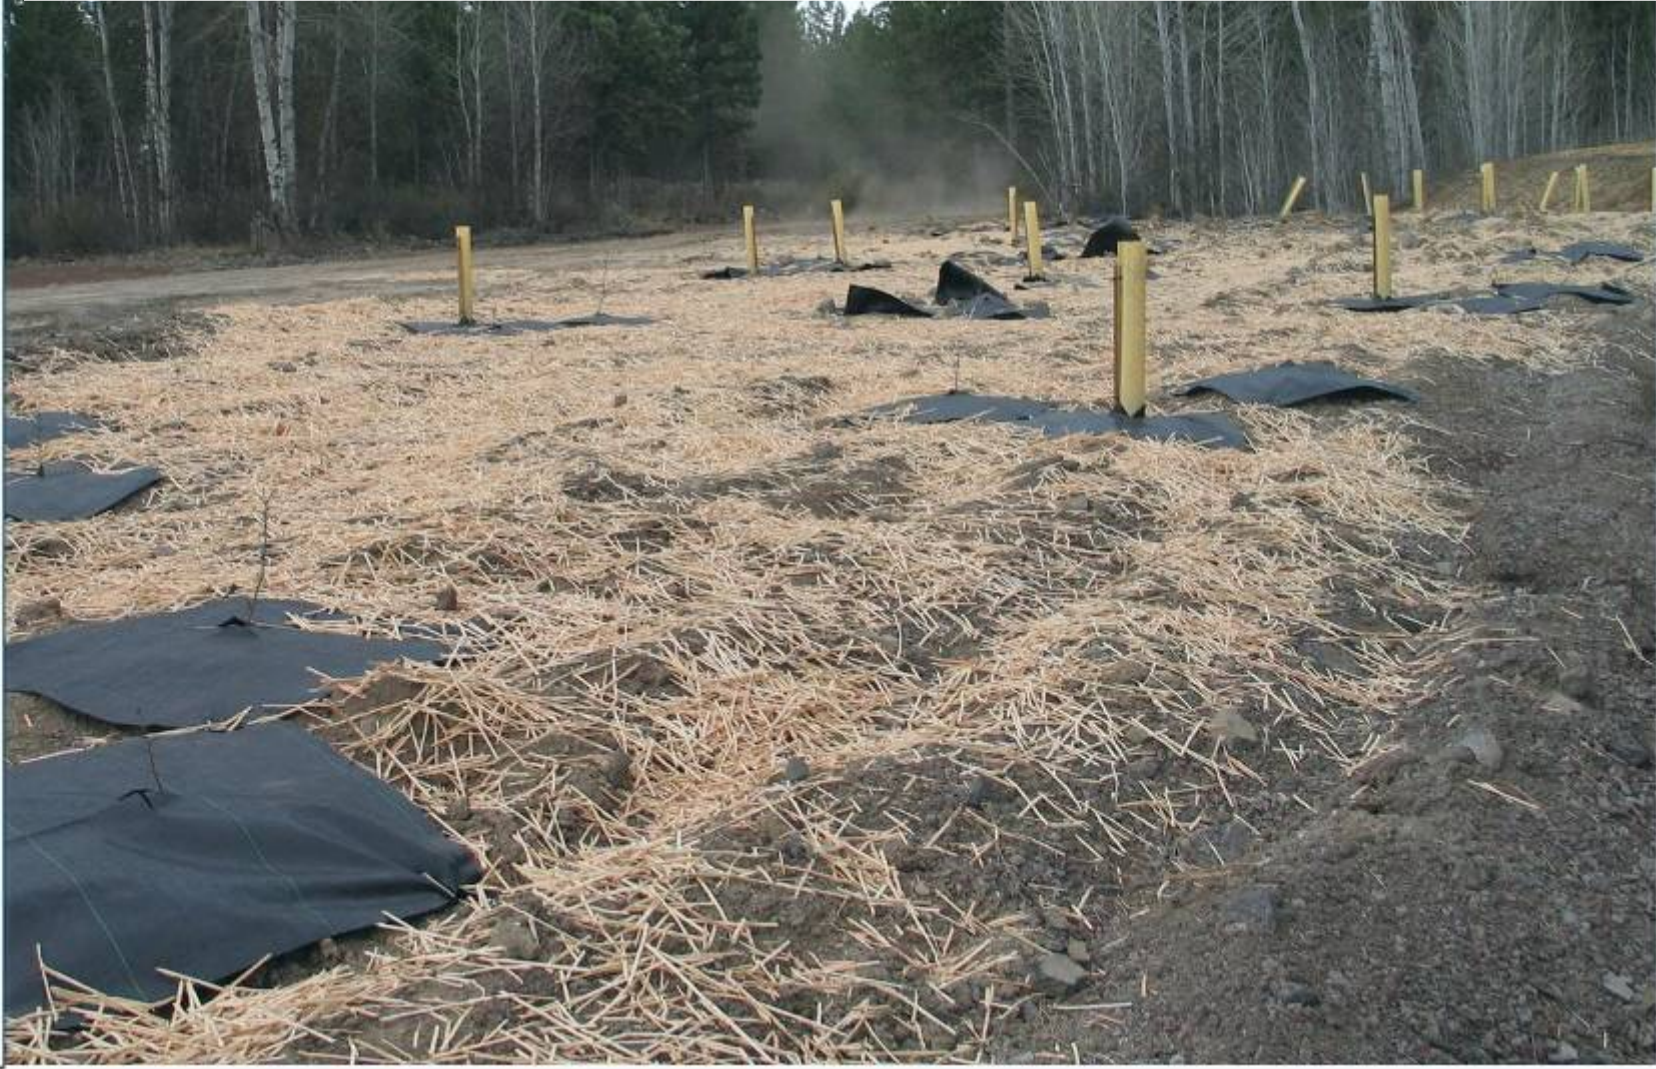
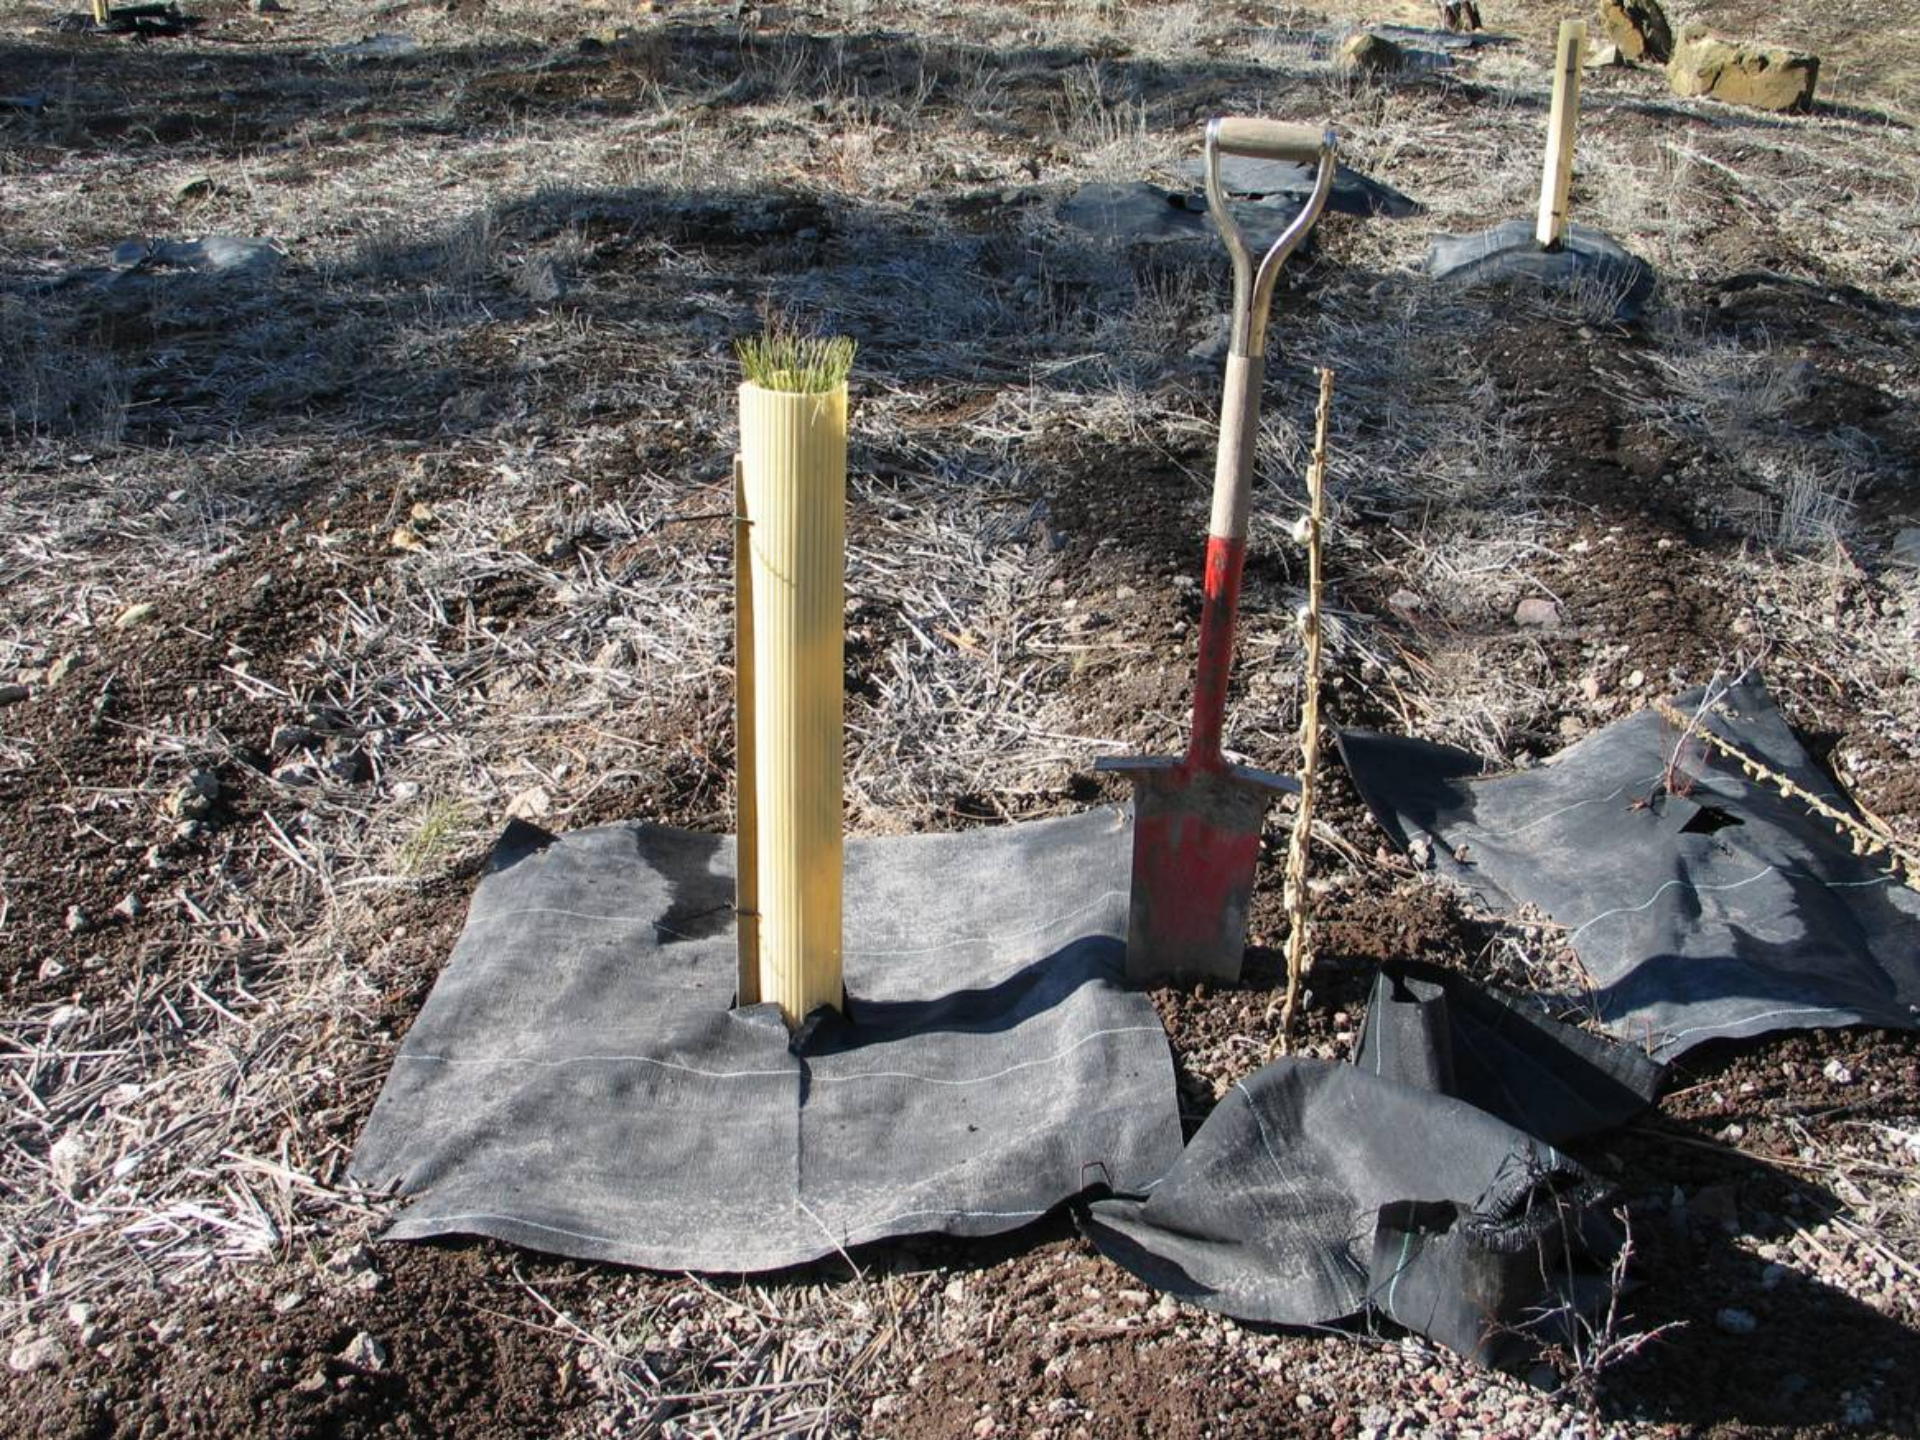
While the ponderosa pine and quaking aspen are growing well after several years and appear to be established, the willows did not survive well, with only a few plants that became established (I have replanted willow stakes this year). The fact that willows are not present in this area might indicate that establishment is difficult. Soil survey prior to road construction indicated bedrock within 24” of the surface in the draw. I was not on site when they re-contoured the draw, but if shallow soils were present in this area, this would explain why willows did not perform very well. The fact is that this area is very dry most of the year and explains why wetland species are not obviously present. While it might be wet from March through a portion of April, it is very dry the rest of the year.
