Establishing Native Grasses On Soil Faced Retaining Walls

by David Steinfeld, Scott Blower, George Fekaris, and Mike Miller

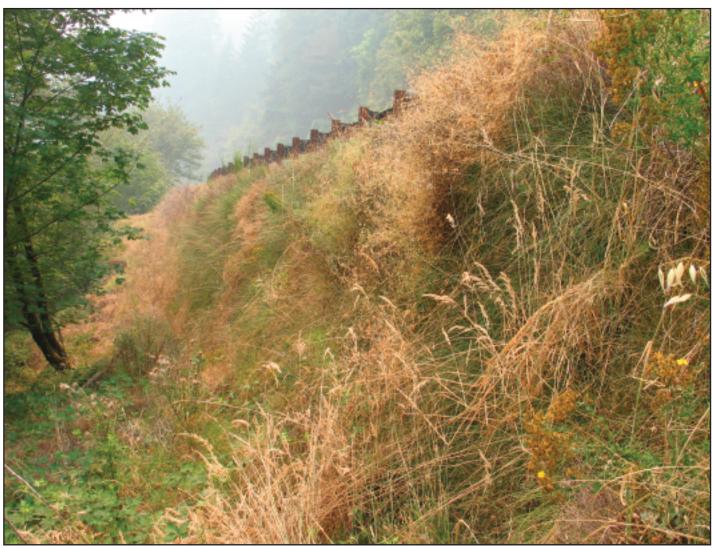
Three years after installation, native grasses are well established on 20 feet high soil faced retaining walls.

following year, the grasses had matured into a well established cover. Monitoring plant cover in the third year showed that over 90 percent of the walls were covered by grasses and less than 10 percent of the

By the following year, the grasses had matured into a well established cover. Monitoring plant cover in the third year showed that over 90 percent of the walls were covered by grasses and less than 10 percent of the walls showed the wire or erosion mat.

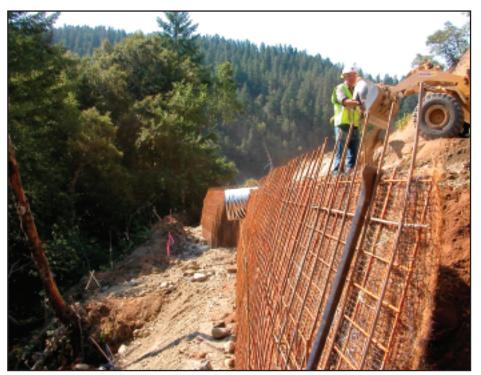
As retaining walls were built, seeded mats were attached to the frames and filled behind with a foot of topsoil.

wire mat over the road base. The wire mat was bent at the end in an "L" shape which formed a two foot high wire frame which became the surface of the wall and held the topsoil after it was placed. As the walls were built, the wire mats were covered with two feet of compacted fill, leaving a foot of space near the surface of the wall where the topsoil would be placed. The wire face of the MSE walls were then lined with the seeded erosion mat and filled behind with topsoil. The side of the mat with the glued seeds were placed facing toward the soil, so that there was good seeds to soil contact for optimum germination and seedling establishment. Once placed, the soil was hand tamped, but not overly compacted, assuring that roots would easily penetrate the soil. When this was completed, another layer of road fill was placed until the road was built up to grade. As the walls were being built, topsoil was also placed at the base of the retaining walls to a depth of 3 feet to create planting sites for shrub and tree seedlings and exposed soils were stabilized with hydromulch, tackifier, and a seed mix of native species.

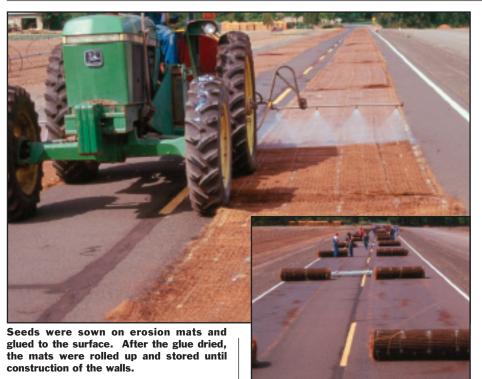
The first year experiment to establish grasses on soil-faced walls failed as a result of poor topsoil and annual weeds. The findings from our test plots proved invaluable for the final project.

of grasses for this specific project area. Installing simple, inexpensive trials are invaluable because the findings can have far reaching effects for how a project is designed. For example, the first year findings from our small plots were a bust because the soil we used for topsoil was full of annual weed seeds. While the weeds hid the walls the first year, by the second year, the weeds had died out and there was just dead thatch remaining on the experimental walls. If we had not learned from these plots, we would have most likely been unsuccessful in revegetating the retaining walls within the project area. Based on this information

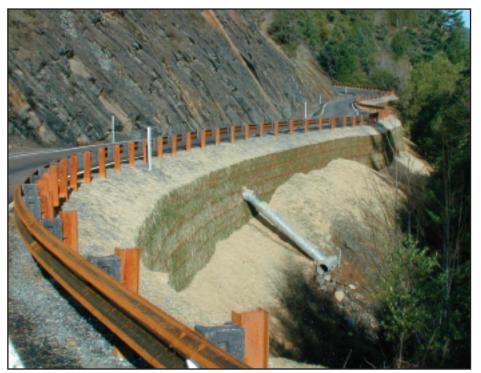
Above: 2003. Grass seeds began to germinate in late fall, three months after wall installation. Below: 2006. Three years later, retaining walls are screened by strands of native grasses.

Summers in the Siskiyou Mountains are long and hot, with at most only a few rainstorms passing through for a couple of days. For this reason, it was not until fall, when storm fronts from off the coast brought sustained rains, that seeds began to germinate. Young grass plants took hold over the mild fall and by winter a green sheen could be seen on all the walls. The top-

The grasses continued to grow in the spring and by summer 2004 it had become harder to make out any details of the wire or erosion mat that held in the topsoil. Grasses stayed green throughout most of the summer which was unexpected considering the hot, dry weather and the lack of an irrigation system. By the

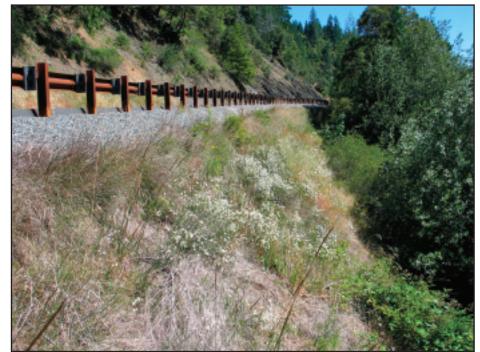
Two forb species were added to the seed mix-nude buckwheat (the white flower) and Oregon sunshine.

grass and forb seed production beds at J. Herbert Stone Nursery. After several years of growing, enough seeds were harvested for this project and other adjacent wildlife projects on the Rogue Siskiyou National Forest that required native, locally adapted grass and forb seeds for restoration. California fescue was the main species glued to the mats, but we also used two native forb species common to the area, Oregon sunshine (*Eriophyllum lanatum*) and naked buckwheat (*Eriogonum nudum*) to add color and interest.

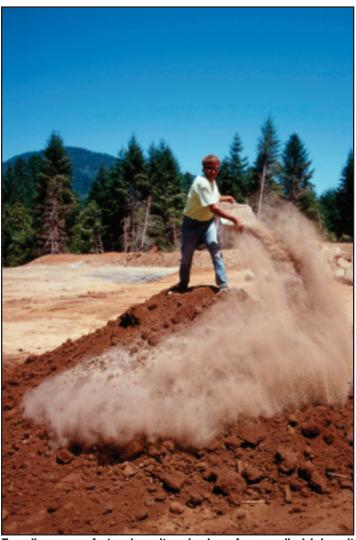
Topsoil was manufactured on site using loam from an alluvial deposit and mixing it three bucket loads of loam to one bucket of compost. Lime, slow release fertilizer, and mycorrhizae were added and then thoroughly mixed in.

The organic matter came from the compost produced by J. Herbert Stone Nursery. This material was trucked to the site and mixed in with the alluvial loams at a rate of one part compost to three parts loam borrow (25% compost by volume). A slow-release, organic fertilizer was added during this operation because of the importance of having fertilizer available for several years while the vegetation became established. Using a fastrelease, inorganic fertilizer, would allow some nutrients, such as nitrogen, to leach out of the soil before the plants could adequately utilize them. This would definitely be a drawback on this site, which receives over 60 inches of rainfall in the winter. Lime material was also applied to raise the pH to above 6.0. Using a front end loader, these materials were thoroughly mixed, then stockpiled on site until the material was needed for wall construction.
