**Chiloquin Highway  
Revegetation Project  
Final Monitoring Report**

**March 29, 2007**

**David Steinfeld**

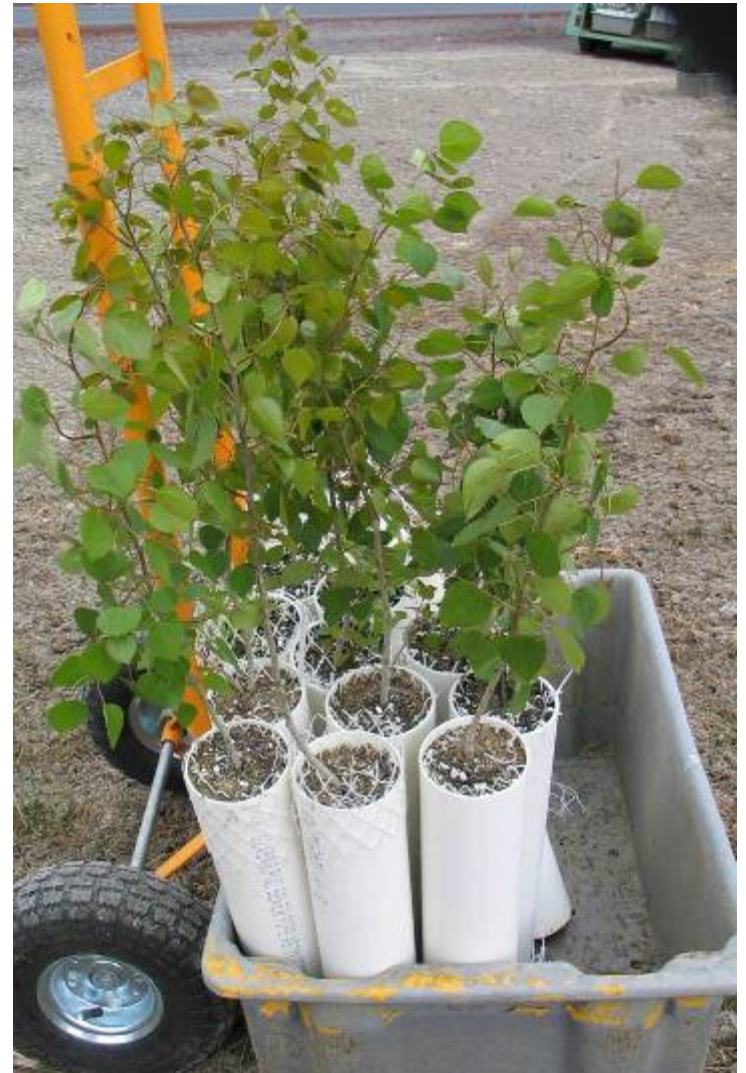
*Quaking aspen in 18” containers*

Tree shelters were placed around quaking aspen, bitter cherry, and service berry after planting to increase growth and reduce animal damage. The plant extends above the shelter several feet before it is removed. This photograph was taken two years after planting. The aspen grew out of the tree shelter and was 3.5 feet tall. At this point the shelter is removed.

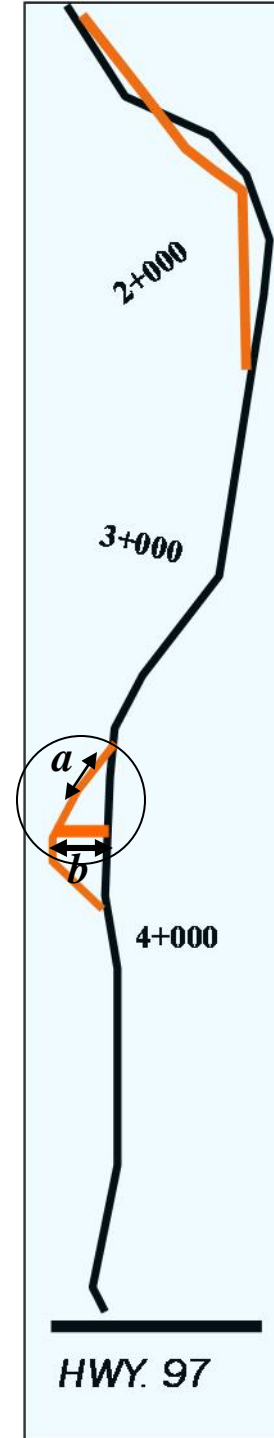
The remaining areas, outside of area “a” have well-established stocking and are growing well, as shown in the following pictures.

Area “b” was not planted in March 2004 because of a large slash pile that still remained in the area at that time and the lack of seedlings available (this area was not originally in the revegetation plan). A unique stocktype was developed for this section which involved repotting small containers of ponderosa pine in the late summer into long tubes that would be ready the following spring. This large stocktype would normally take a year to produce but we were pushing to get it ready in 6 months. We used 30” tree shelters instead of PVC or one gallon containers to plant the containers in. We held the media in the treeshelters together with zip ties. By the spring the root system had grown over two feet to the bottom of the container and were ready to plant. Because all we had to do was cut the zip tie, we could keep the media intact with the root system and plant without losing the media from around the roots. This resulted in very fast growing ponderosa pine. After the trees were planted, we placed the tree shelters around each seedling to protect and increase seedling growth. Tree growth for these seedlings is very high.

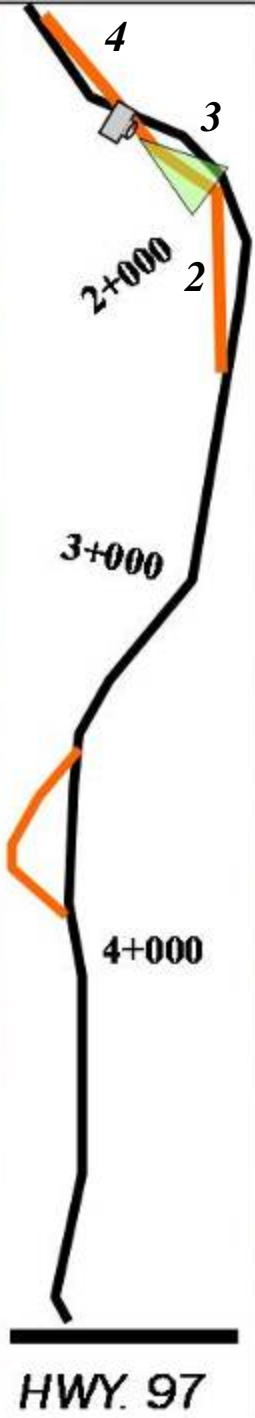
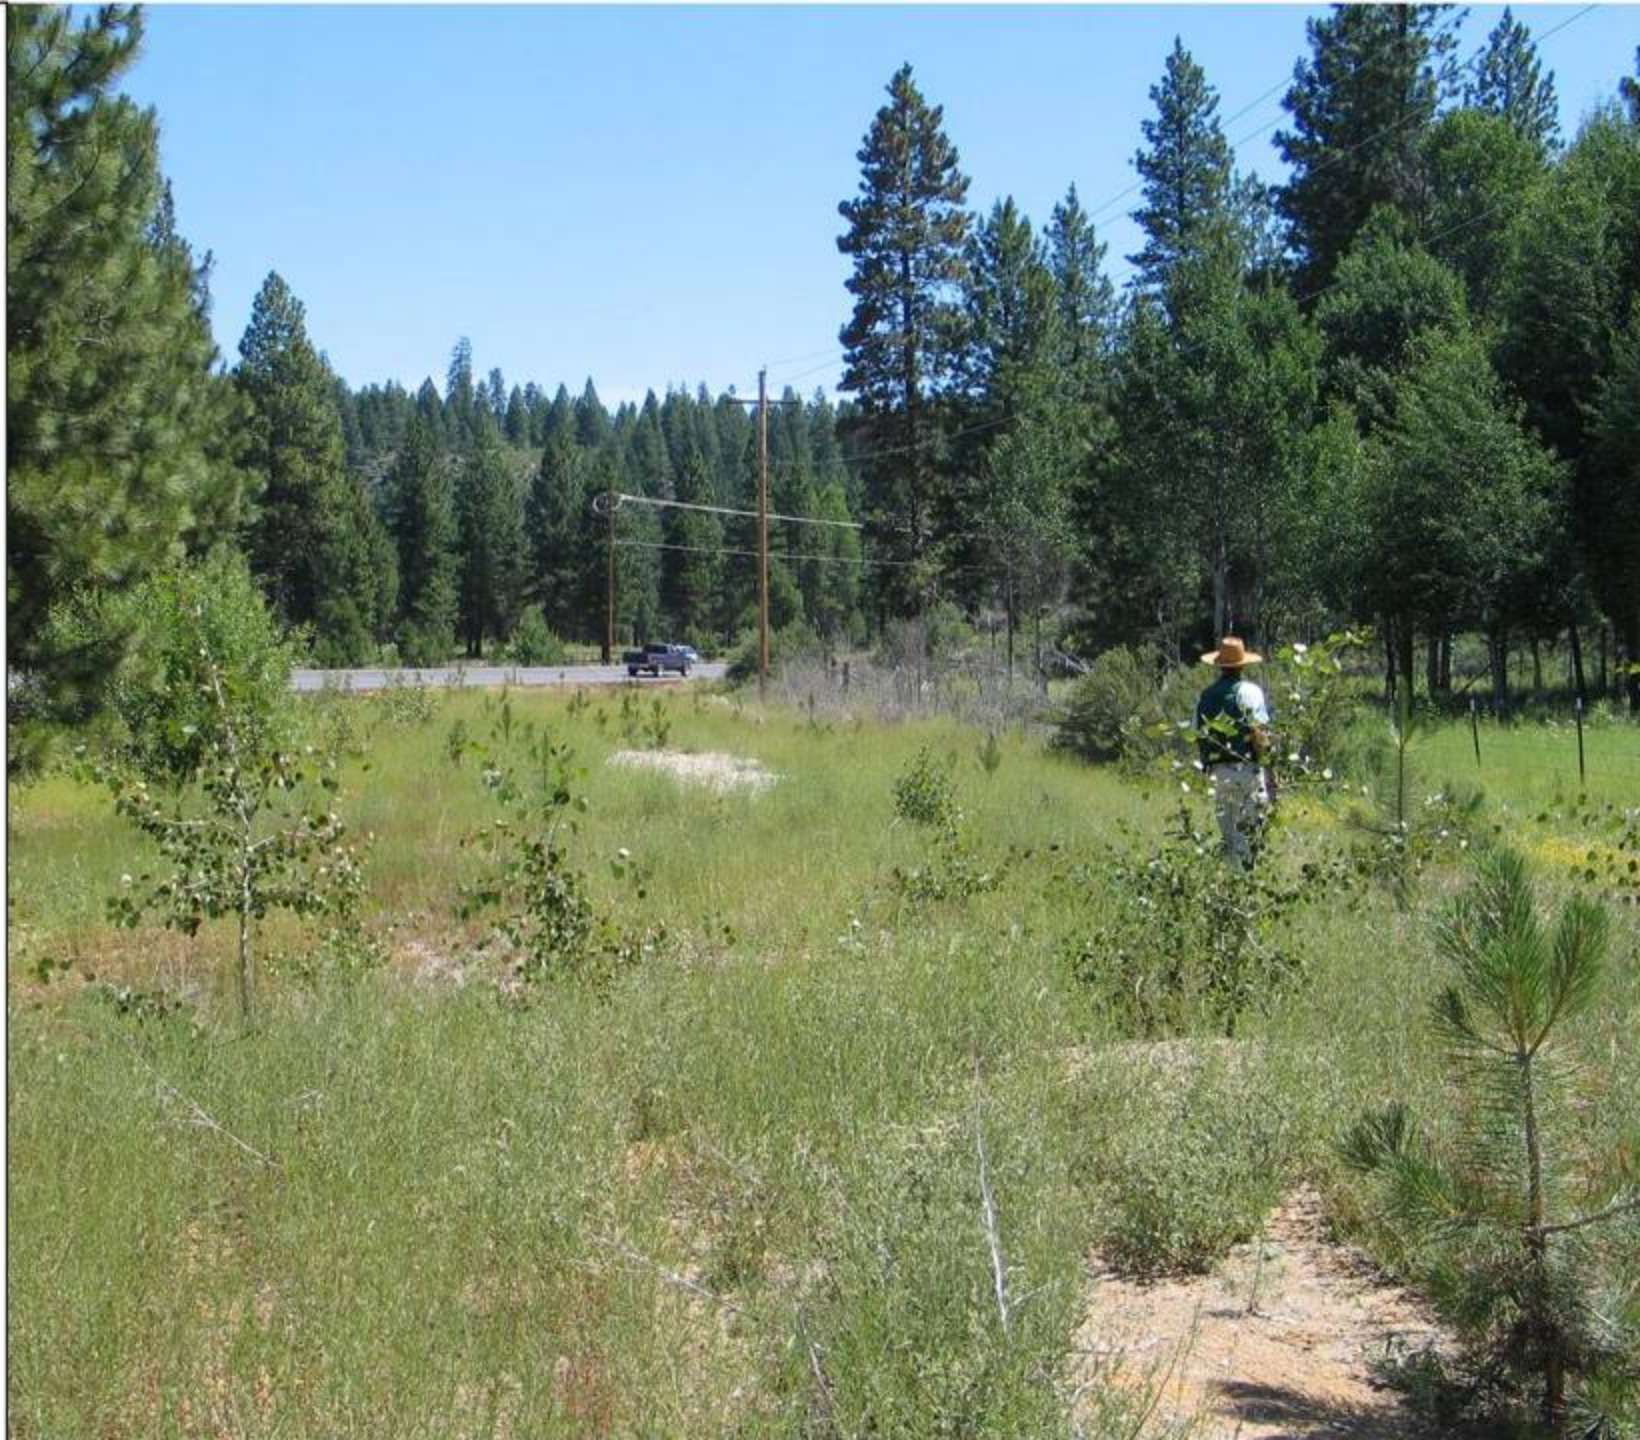
Sections 2, 3 and 4 were planted with the following species and stocktypes. Survival of ponderosa pine was above 90% for planting areas 2 and 3, and around 85% for area 4. All areas are well-stocked and free to grow.

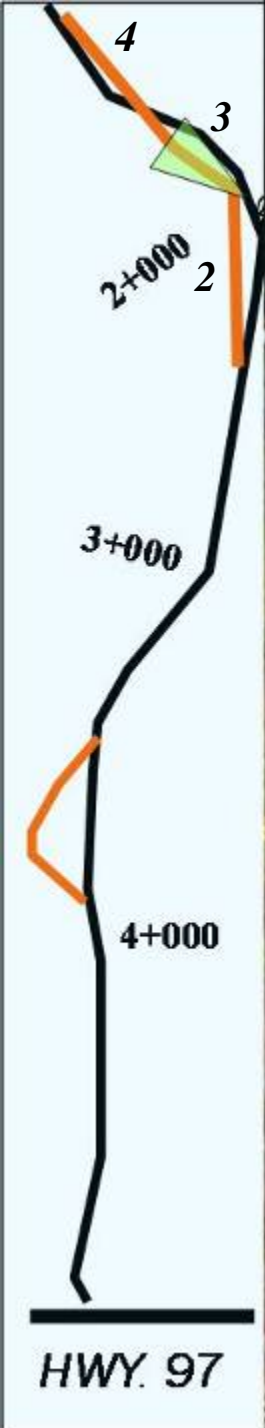
**The black cloth over the top of the ponderosa pine are bud caps we placed to protect the seedling from the cone moth**

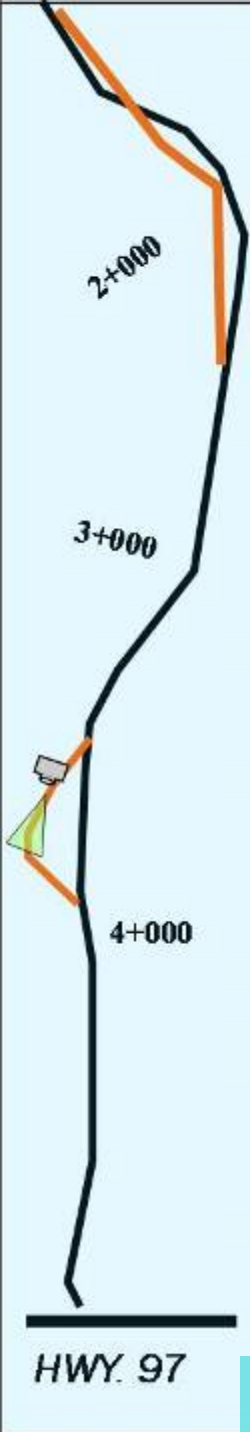
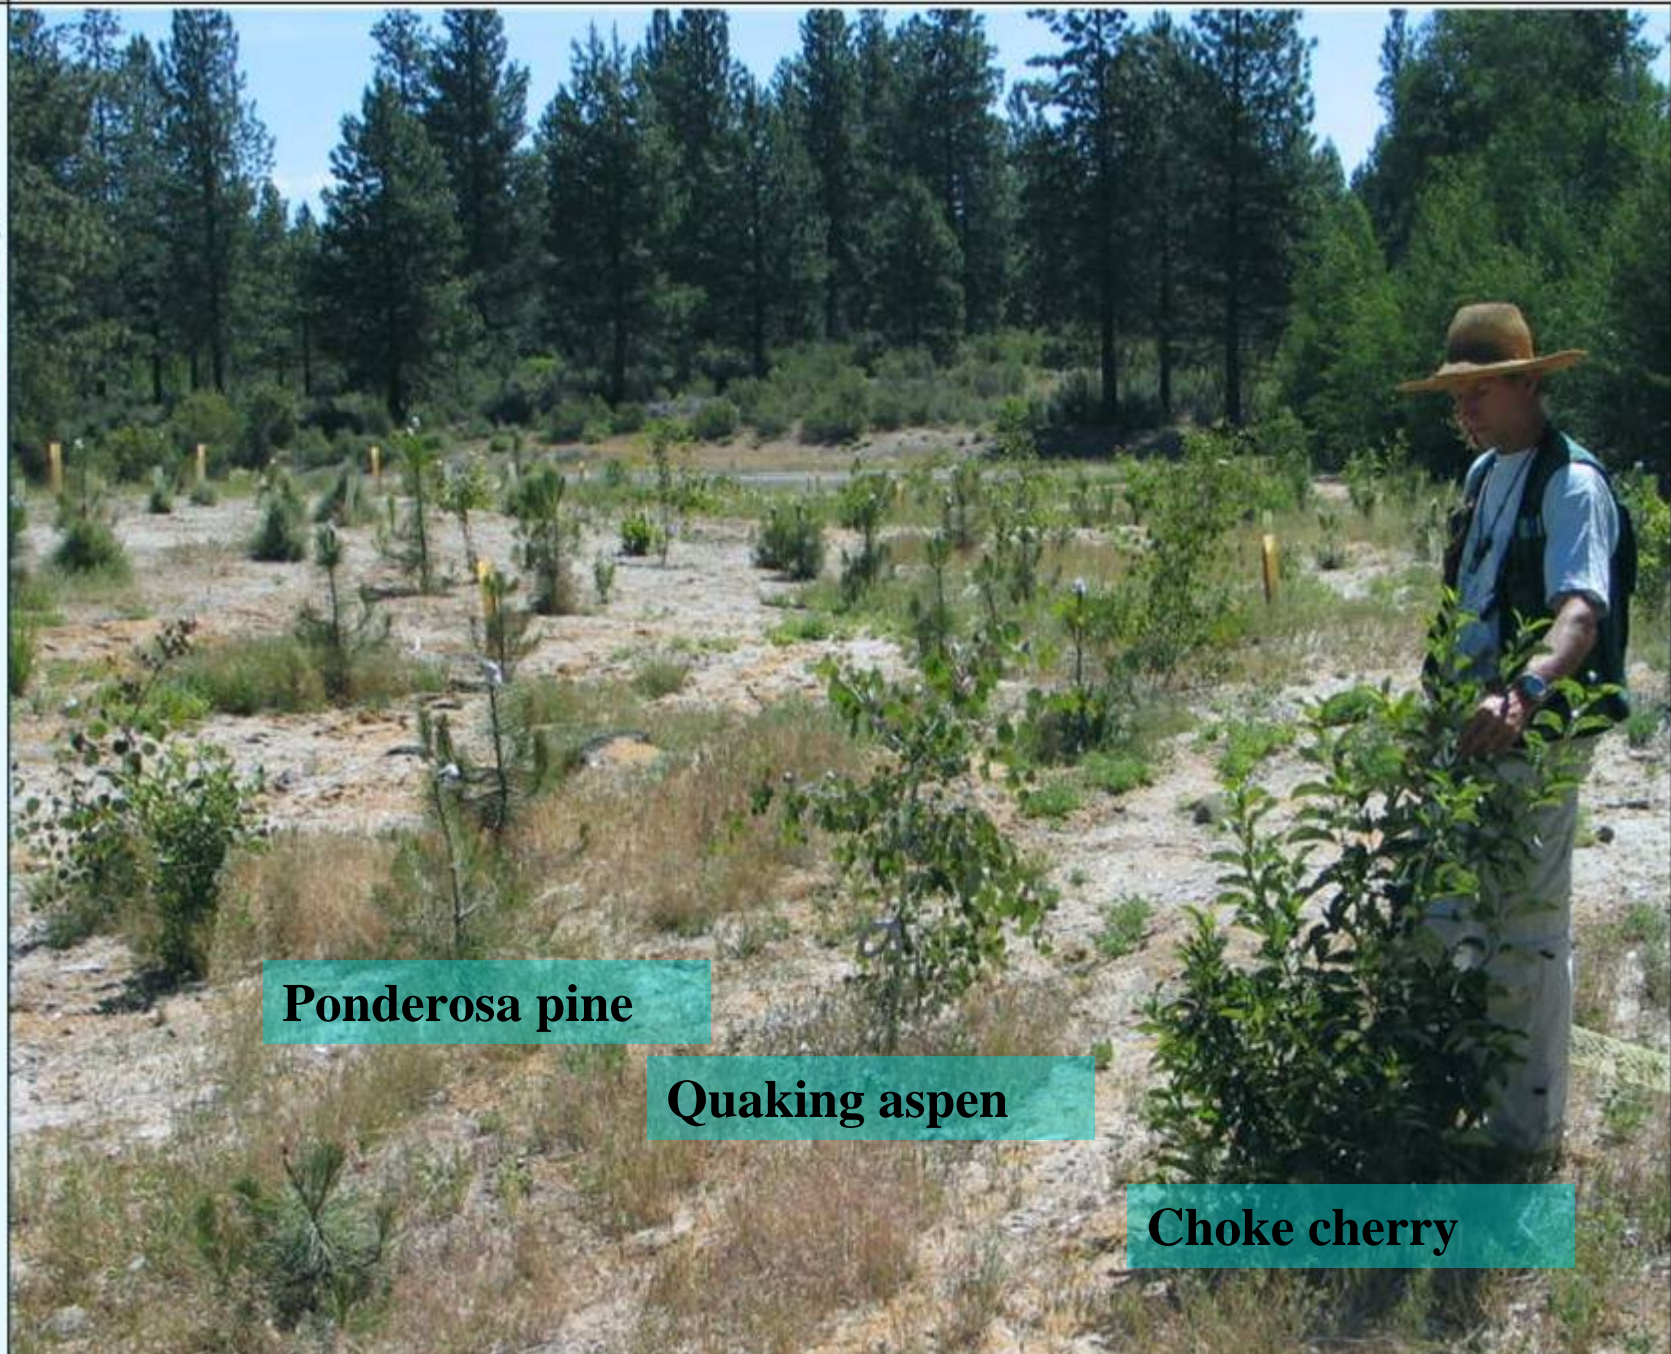
**Eastern section of Planting Area 1 – well stocked**

Aspen will average almost 6 feet after three years and ponderosa pine 3 feet in three years which is considered exceptional growth for this area.

**Ponderosa pine**

**Quaking aspen**

**Choke cherry**

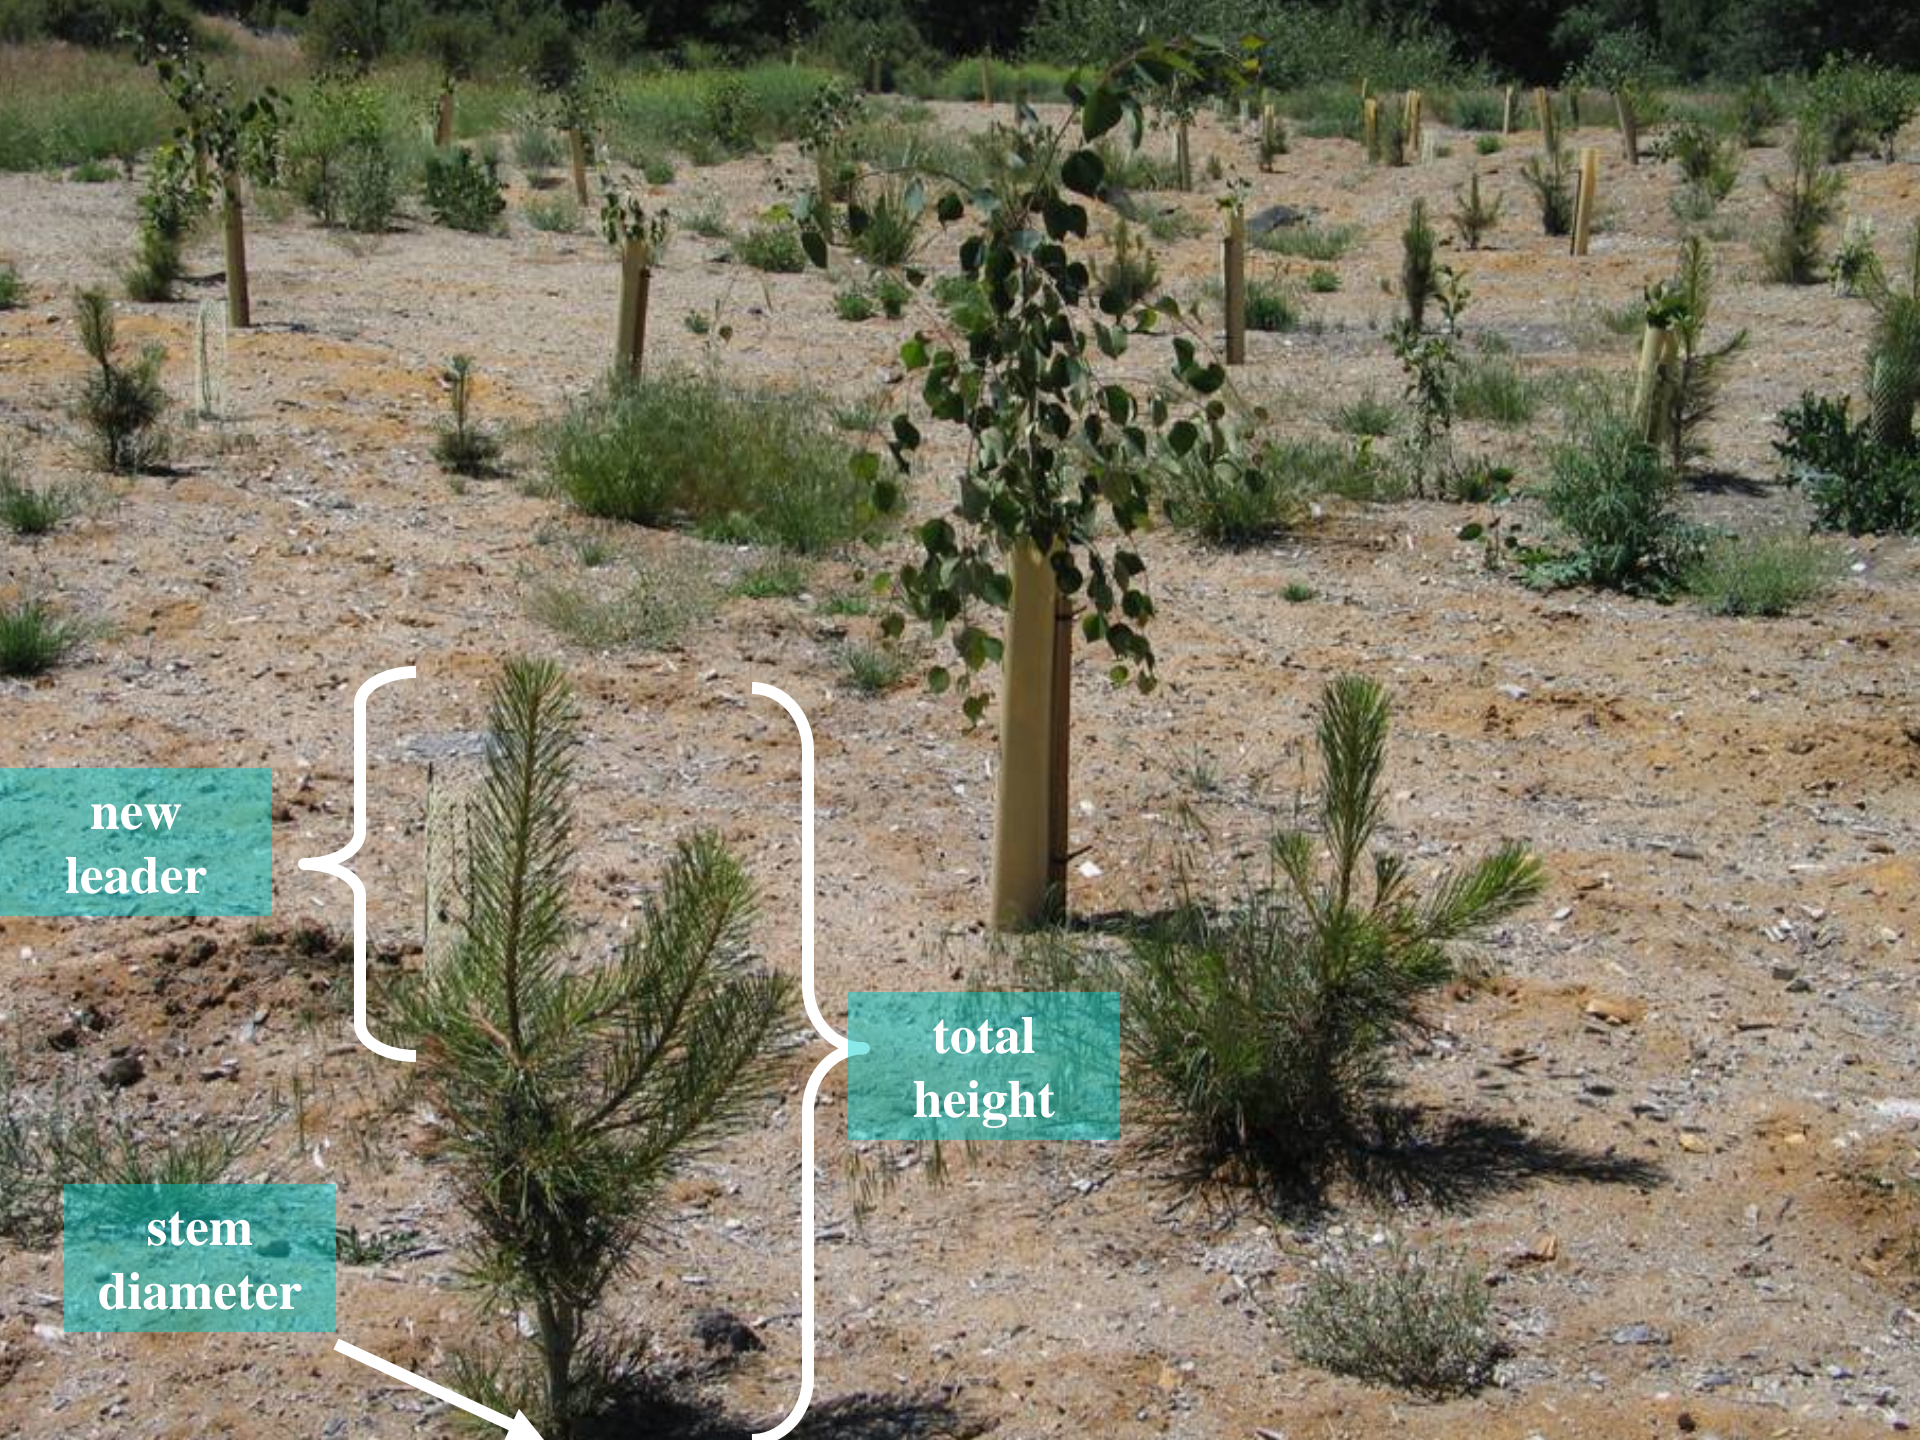
<b>Species</b>	<b>Container</b>	<b>Growth</b>	<b>Comments</b>
<b>Ponderosa pine</b>	14" pots	Good	On trees without insect damage average height = 34 inches, last years leader growth = 10 inches, and stem diameter = 1.3 in
<b>Bitterbrush</b>	18" tubes	Fair	Average height is 2 feet and diameter cover is 20 inches. There are many natural seedlings that were found in the plots.
<b>Quaking aspen</b>	18" tubes	Good	Good appearance and growth - 57 inch average height and 1 in average stem diameter
<b>Choke cherry</b>	12" tubes	Good	Healthy - 28 inches average height and 0.7 inches

new leader

stem diameter

total height

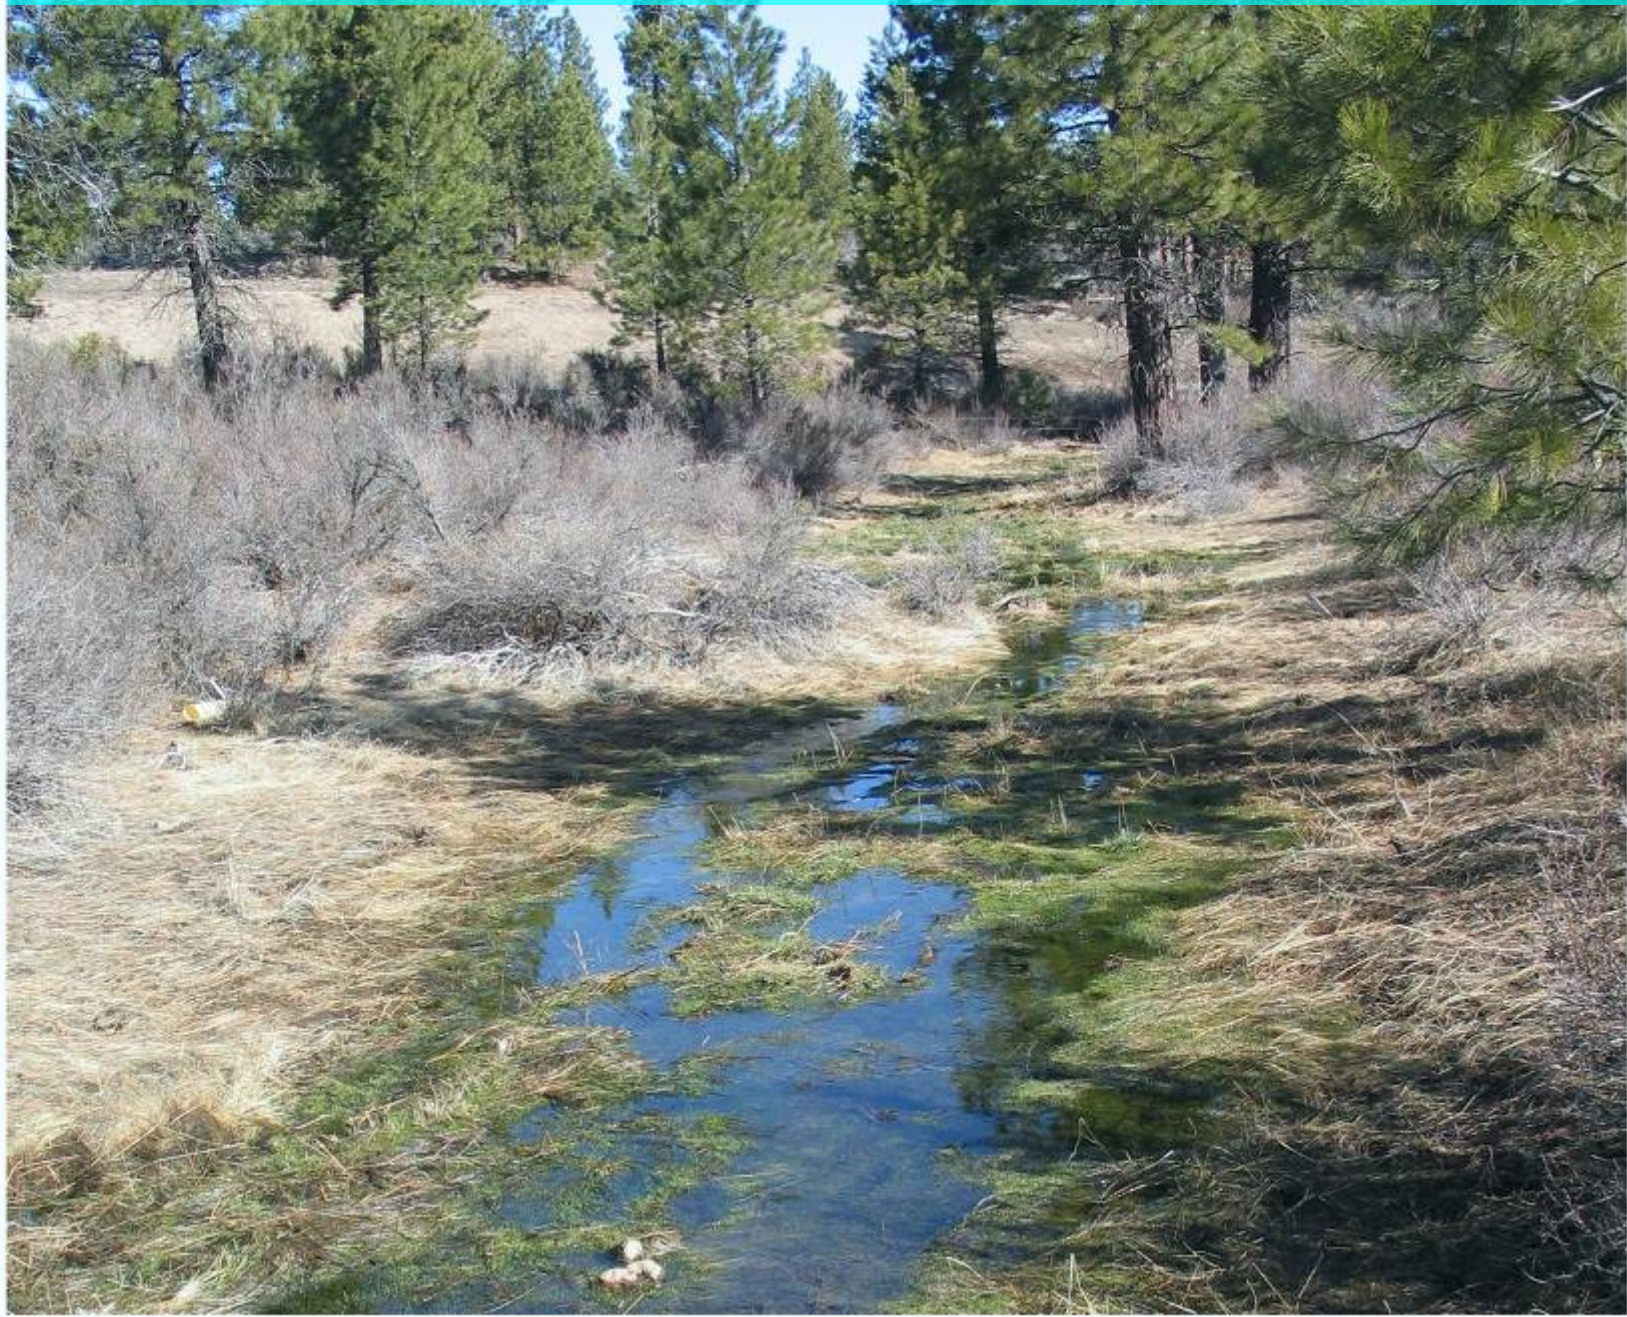
# Undisturbed Draw/“Wetland”

Notice in the following picture the composition of the vegetation. The dominant component is ponderosa pine, followed by bitterbrush understory (both very dry species). There are no sedges, rushes, willows, or other key wetland species. In our plantings, we mimicked this composition.

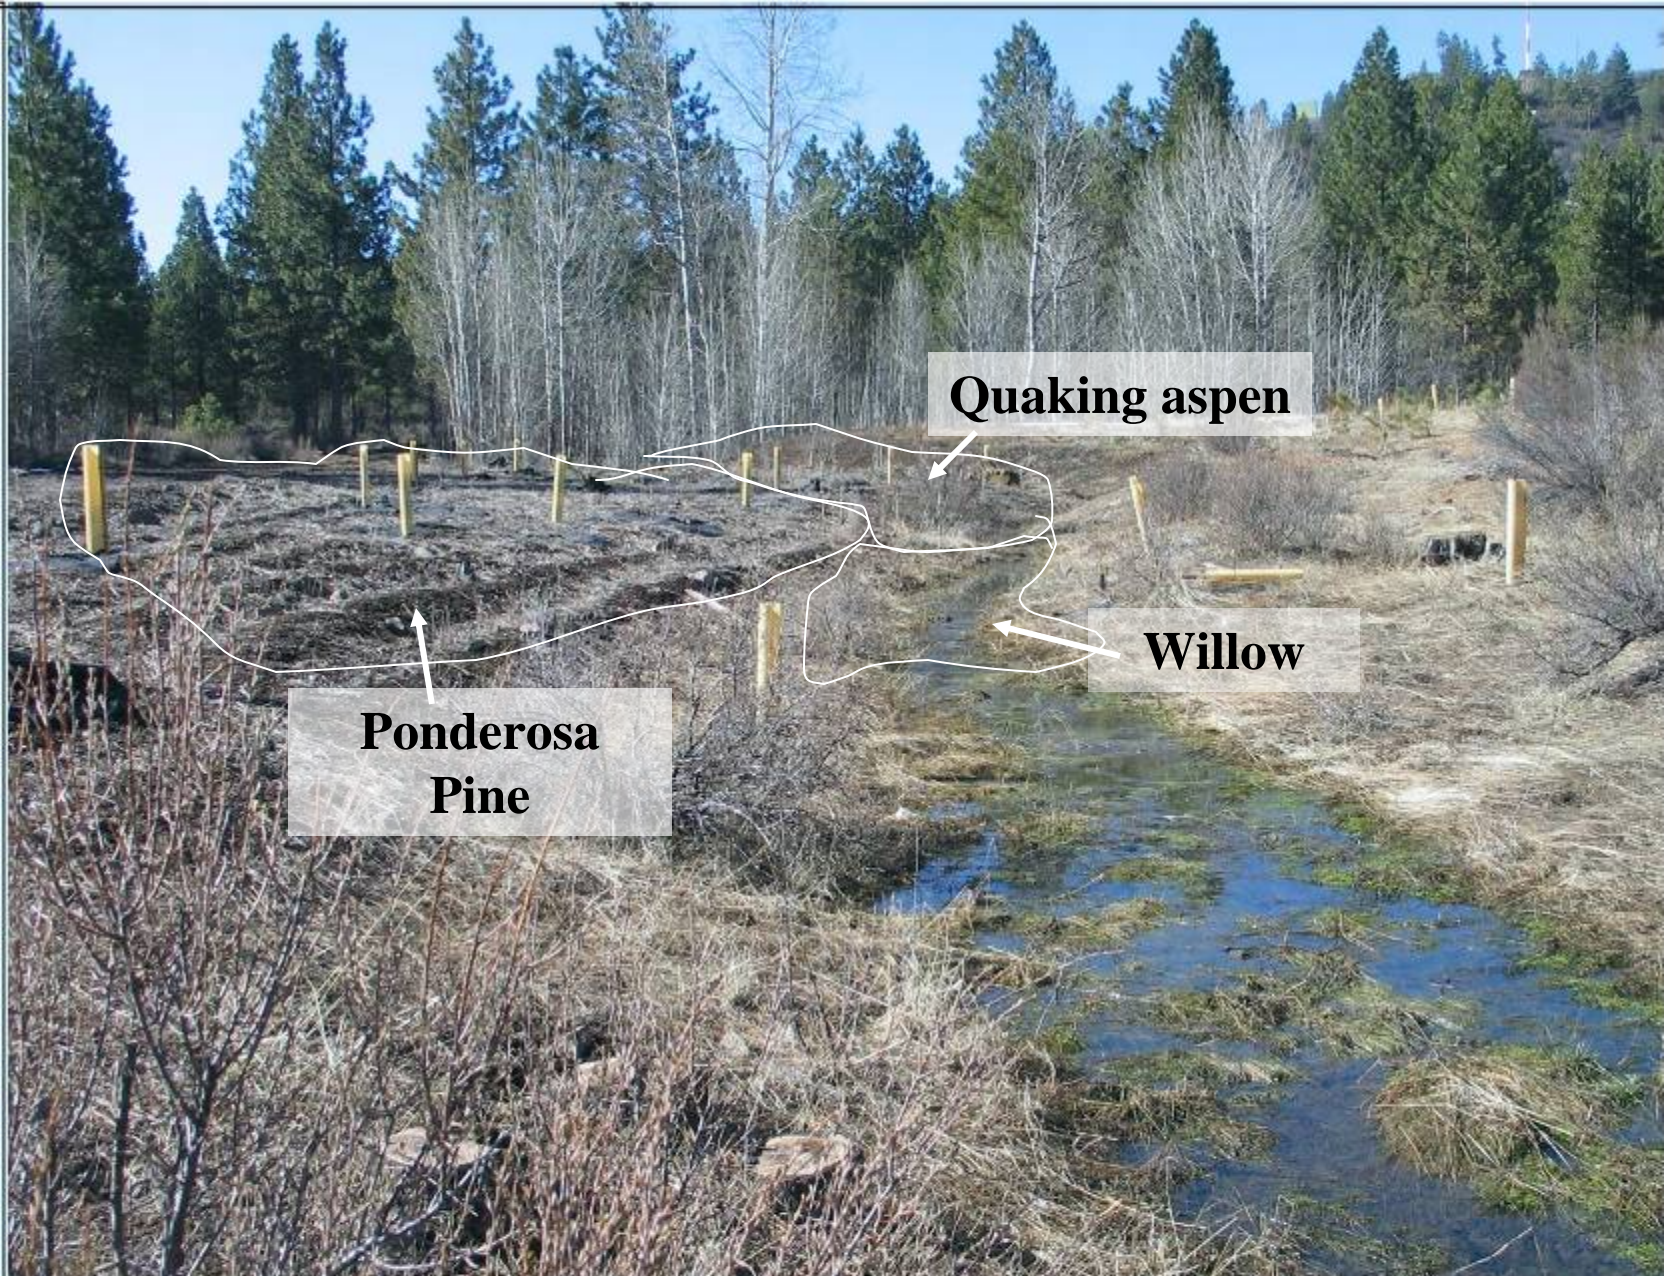
The 150 foot section of disturbance (a) was planted with willows, ponderosa pine, and quaking aspen. The abandoned road approximately 50 feet to the east of the draw (b) was ripped and planted to ponderosa pine, while the upper portion of the draw was planted in quaking aspen.

**This is the section of draw that was reconstructed after the road was abandoned.**

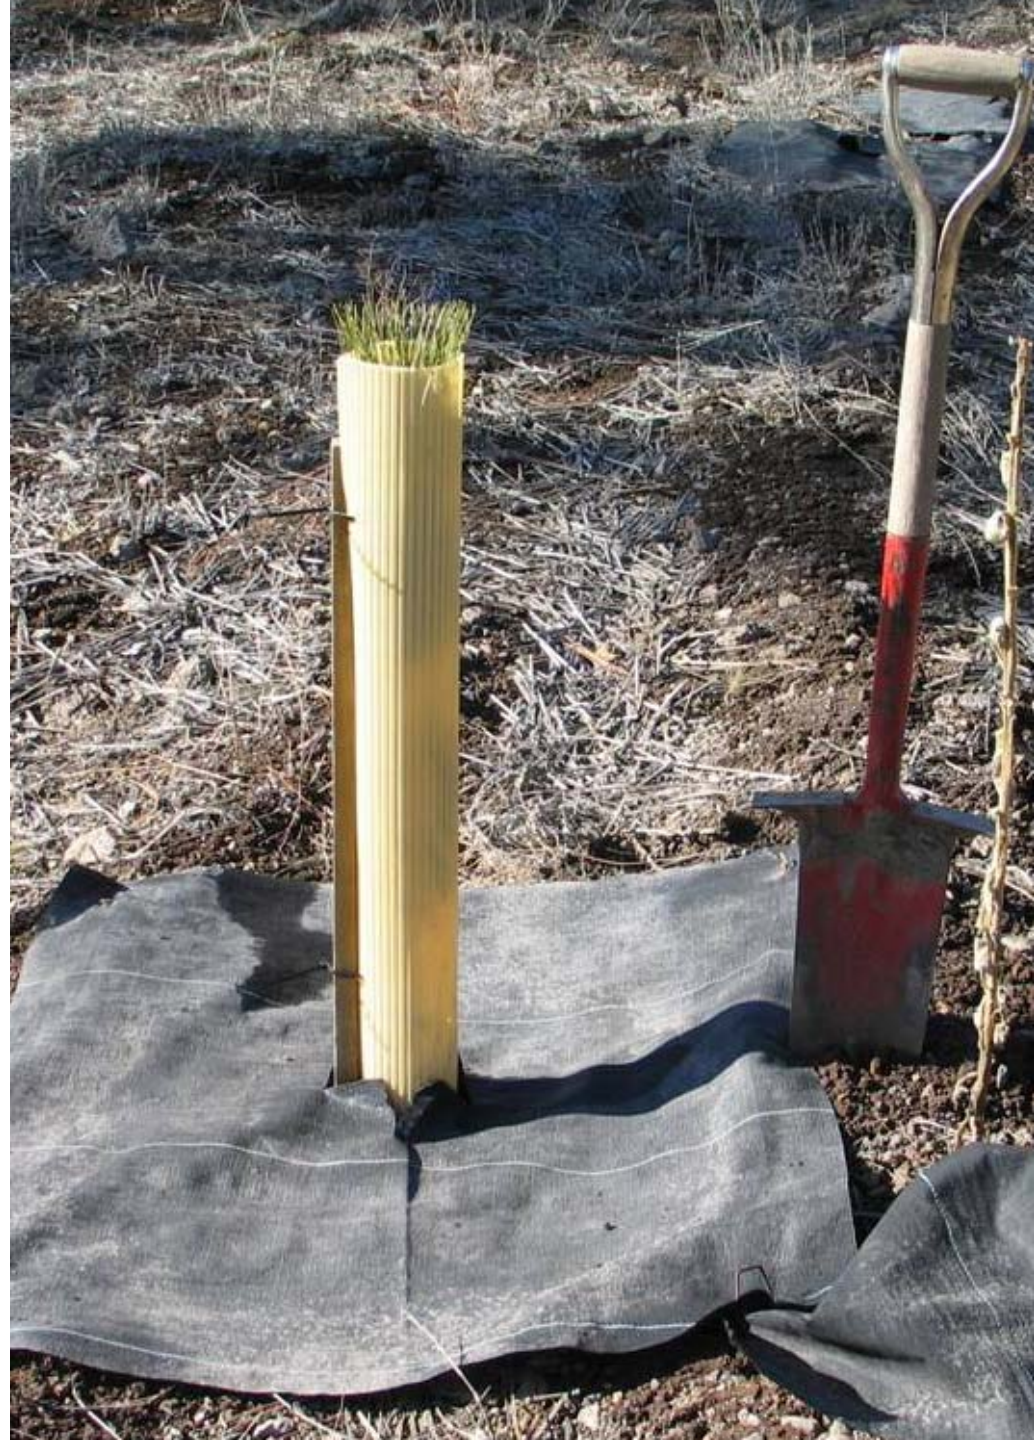
We were not able to rip the abandoned portion of road (b) until the follow year because it had not been obliterated until late 2004 so planting of the abandoned road did not take place until 2005. Because stock was not available, we took the same strategy as was described in Section 1b above. Smaller ponderosa pine containers were grown for six months in a tree shelter (as container). The seedlings are well-established and growing very well (averaging 20 to 24” tall in two years).
