Merlin Landfill Forest Restoration Test Plot Demonstration A Summary of Findings

January 2005

Merlin Landfill Forest Restoration Test Plot Demonstration Work A Summary of Findings

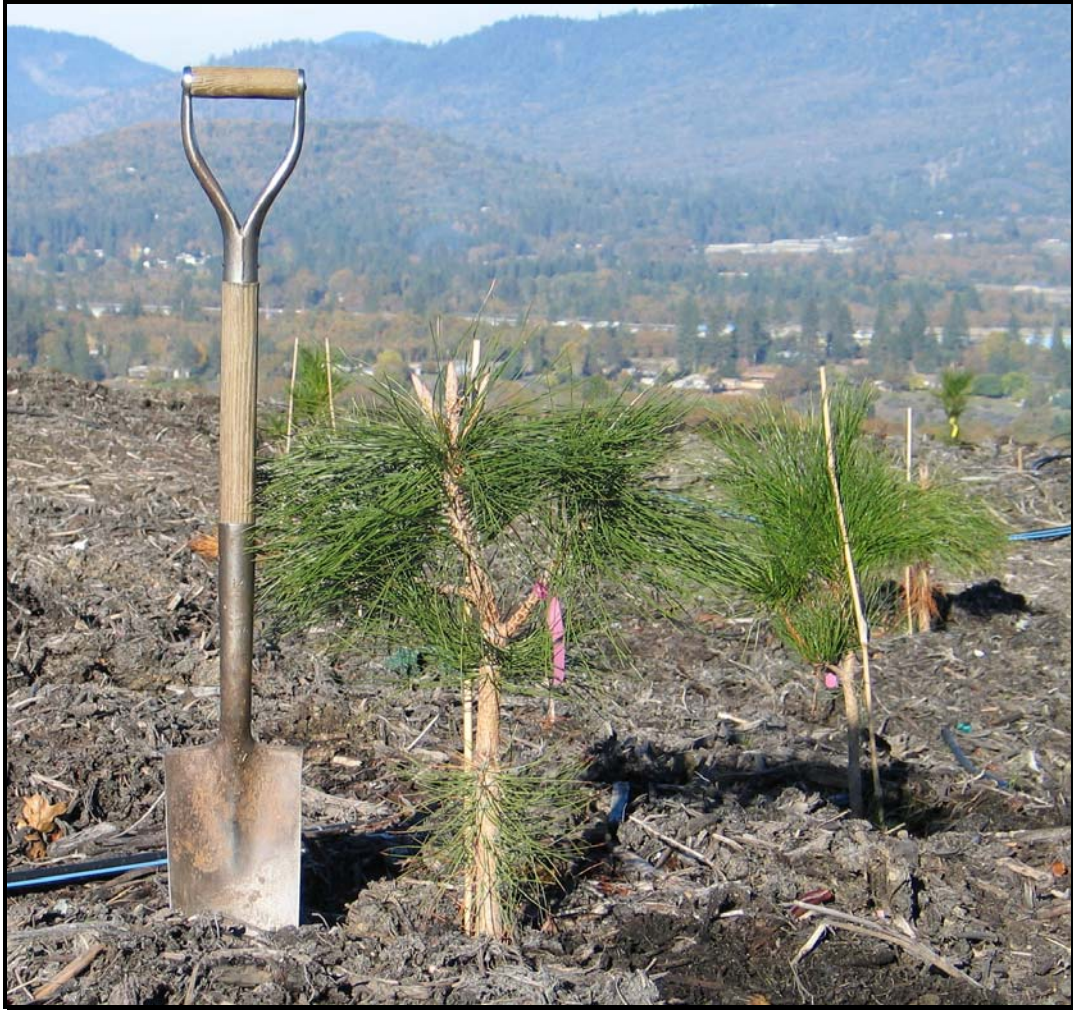
Ponderosa pine – long tube container – Nov 2004

Growth rates for seedling tops were very high for the large container-grown seedlings, approaching a total average height of close to 2 feet, whereas bareroot seedlings averaged just over a foot in height (Figure 6 and cover page picture). More impressively, the large container-grown stocktypes grew more than 40% of their total height after they were planted last spring. The bareroot stock, on the other hand, averaged 25%. It is not unexpected to see the large first year growth differences between bareroot and large container-grown stocktypes, primarily because most bareroot seedlings often experiences some level of “transplant shock” immediately after outplanting. However once established in the second or third years after outplanting, bareroot seedlings often grow well. It is unlikely however, that the bareroot seedlings catch up to the growth rates of the large container-grown seedlings.

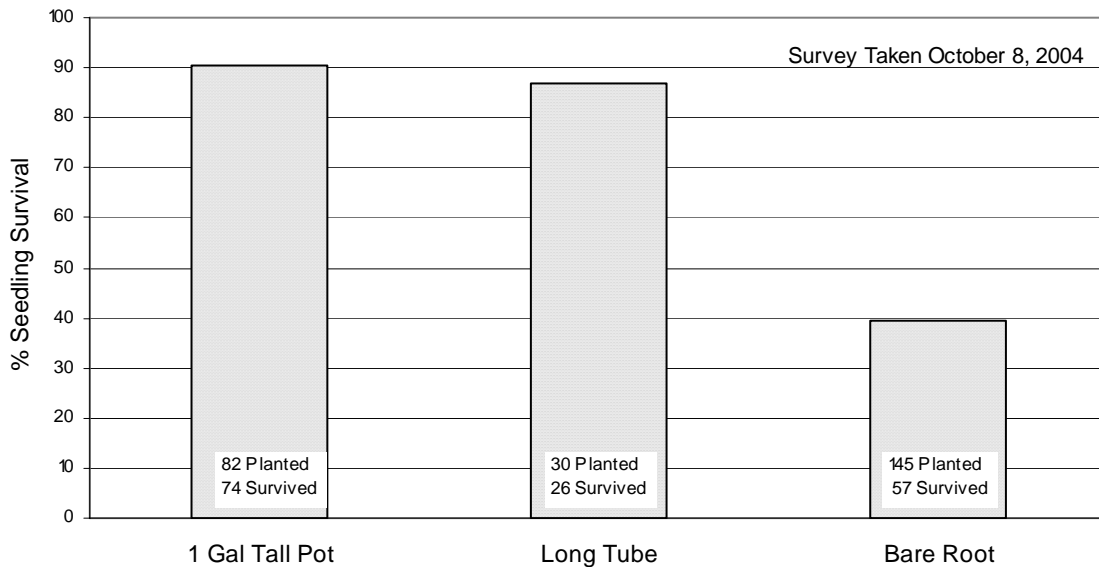
Figure 4. Seedling survival by stocktype

Seedling survival was conducted on five different occasions over the summer and fall. A 100 percent survey of all planted seedlings taken on October 8, 2004 showed that of the 257 trees planted, 157 survived for a total seedling survival rate of 61%. By planting area, of the 212 seedlings planted on Site 1, 136 survived and 21 survived out of the 45 seedlings planted on Site 2. Initial stocking levels for both areas are approximately 135 seedlings per acre. Seedling mortality occurred primarily in the bareroot stocktype (Figure 4) with more than 60% of the seedlings dying by the end of the summer. The large container-grown seedlings (1-gallon tall pots and long tubes) on the other hand had very good survival, displaying less than 15% mortality.

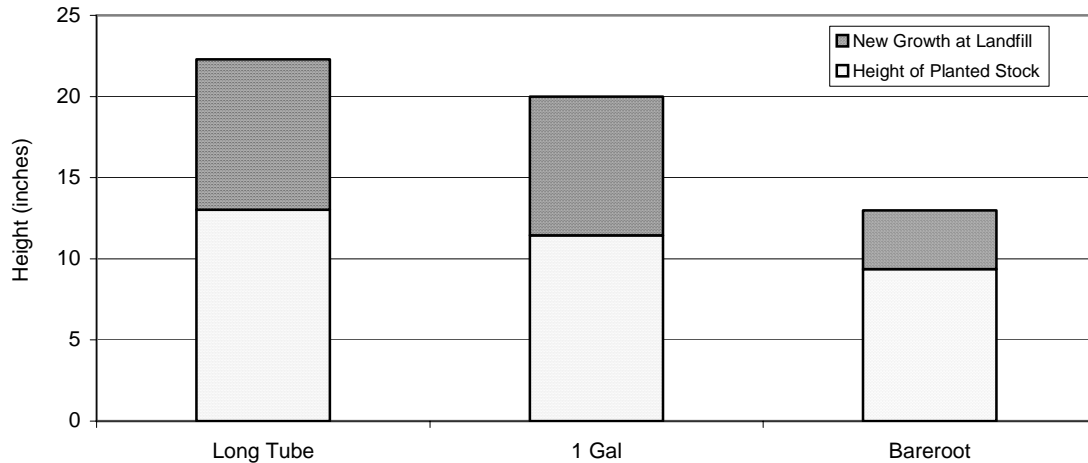
Figure 6. Height and leader growth of planted stock (November 5, 2004)

Figure 6 gives a good indication of the type of growth rates that could be expected in the short term on this site. Assuming no unforeseen problems arise, it would be realistic to expect a minimum growth rate of one foot a year to continue for the foreseeable future. This would mean that in a decade, seedlings would be over 10 feet and show some visual presence from a distance and within two decades, the site would be dominated by 20-foot tall saplings.

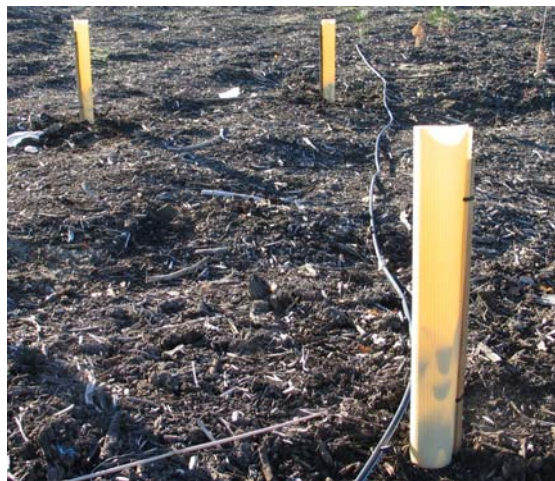
Figure 8. Tree shelters placed around madrone seedlings to protect from deer browse, increase air temperatures, and reduce moisture loss.

and they are being protected with tree shelters (Figure 8). These structures act like mini-greenhouses, allowing solar radiation in, protecting the seedling from wind desiccation and creating a high moisture environment. Under certain situations, moisture will condense on the walls of the tree shelter at night and drip into the soil, adding soil moisture.
